Manhole Inspection Summary

Manhole # S21G1_010MH

Location Address: **2500 puget st**

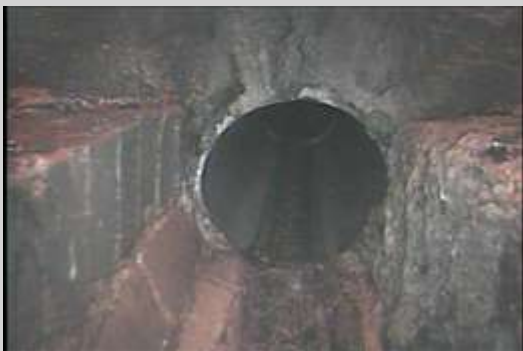
6 O'Clock Inflow

Pipe Height: **8.4** (in.) Rod and Bar (Angled)
Pipe Material: **Clay** ☐ Pipe Lined
Invert Depth: **10.79** (ft.) Flow Characteristics: **Slow**
Deposits: ☒ None ☐ Mud ☐ Sludge ☐ Debris ☐ Grease
Silt Depth: **0** (in.) Deposits Extent:
Infiltration: **None** Pipe Seal Cond: **Unknown**
